Optimization of Roadway Support in Deep Coal Seams Based on Loose Zone Testing

Abstract

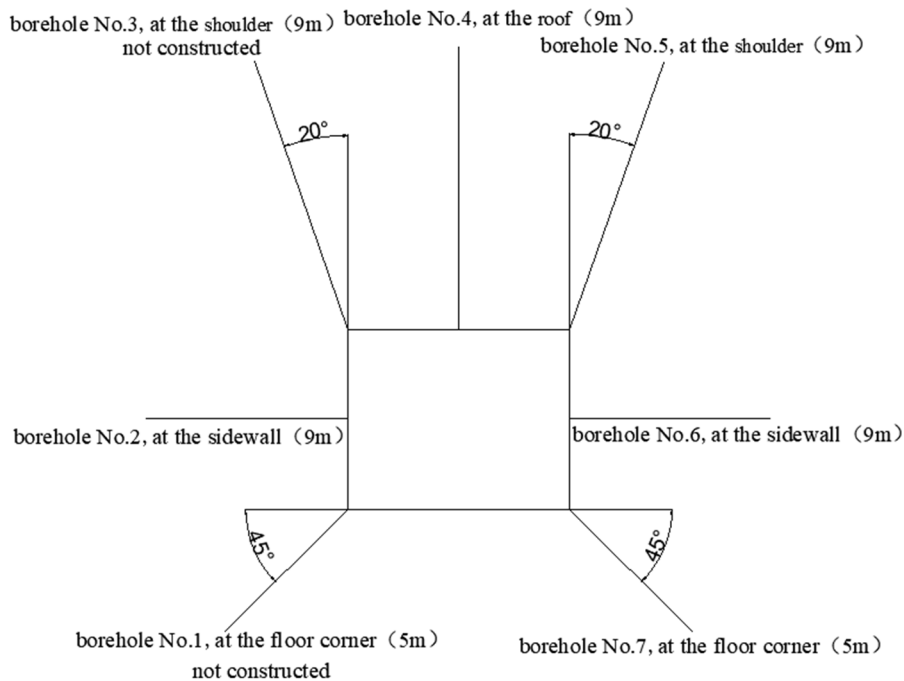
Details of each borehole are as follows: Borehole No.1 (floor corner) was designed to be 5 m deep with an inclination of about 45° to the horizontal but was not completed. Borehole No.2 (sidewall) was 9 m deep. Borehole No.3 (shoulder) was designed to be 9 m deep with an inclination of about 20° to the vertical but was not completed. Borehole No.4 (roof) was 9 m deep; Borehole No.5 (shoulder) was also 9 m deep with a 20° inclination to the vertical; Borehole No.6 (sidewall) was 9 m deep; and Borehole No.7 (floor corner) was 5 m deep with a 45° inclination.

Figure 5. Arrangement of Observation Boreholes in Monitoring Section

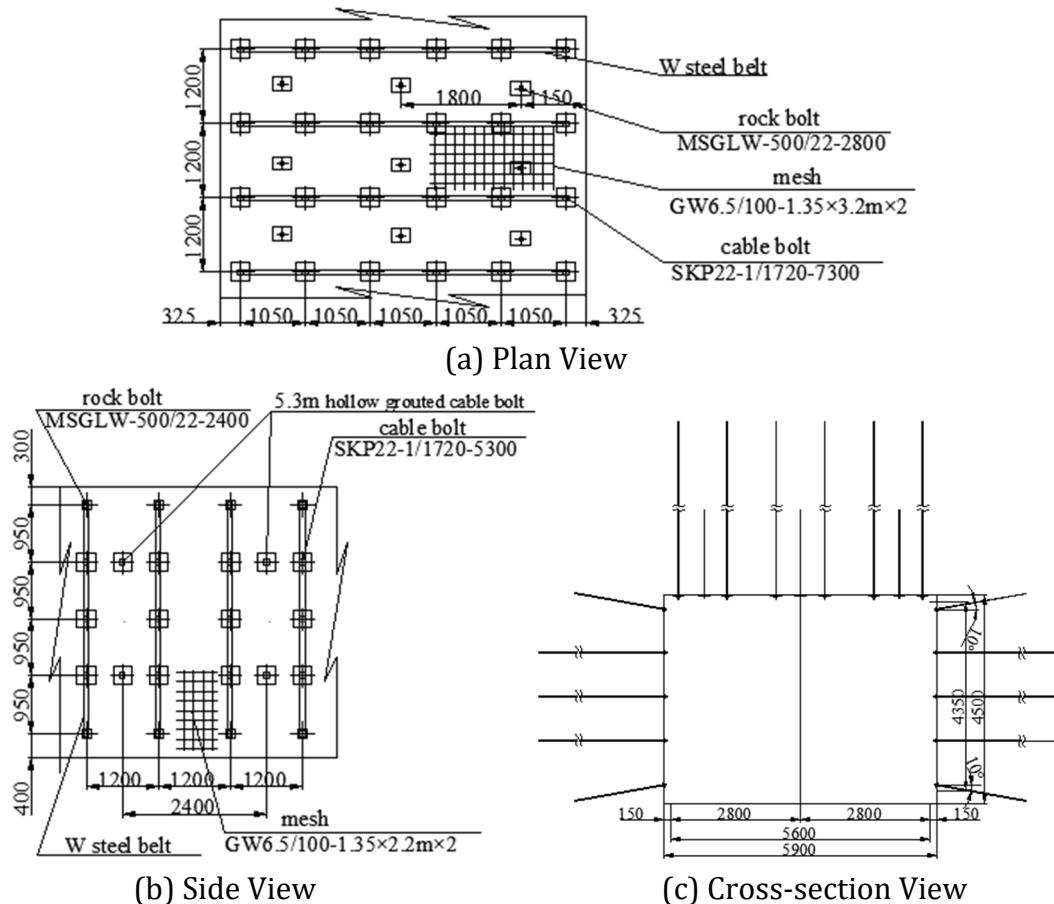
Figure 7. Reinforced Support Design of the 2103 Panel Auxiliary Transportation Roadway (West) Using Grouting cable bolts

In the 2103 Panel Auxiliary Transportation Roadway (West), a rectangular cross-section support system was adopted, with an excavation width of 5.9 m and a height of 4.5 m. To address the issues of fractured surrounding rock and support failure, a reinforcement scheme incorporating grouted cable bolts was implemented based on the original support design. The optimized support layout is shown in Figure 7. For the roof support, ordinary cable bolts of type SKP22-1/1720-7300 were used. The spacing between rows and columns was 1050 mm × 1200 mm, with six cable bolts per row, and the cable bolt nearest to the roadway shoulder was placed 325 mm from the sidewall. In addition, rock bolts of type MSGLW-500/22-2800 were installed with a spacing of 1800 mm × 1200 mm, three per row, with the side bolt located 1150 mm from the roadway shoulder. For the sidewalls, a combined support system of rock bolts and cable bolts was employed. Ordinary cable bolts of type SKP22-1/1720-5300 were installed at positions No. 2, No. 3, and No. 4 along each sidewall, with a spacing of 950 mm × 1200 mm, and three cable bolts per row. Rock bolts of type MSGLW-500/22-2400, each 2400 mm in length, were installed at the top and bottom corners of each sidewall. The top corner bolt was positioned 300 mm from the roof, while the bottom corner bolt was 400 mm from the floor. Furthermore, hollow grouted cable bolts with a diameter of 22 mm and a length of 5.3 m were used, spaced at 1900 mm × 2400 mm, with two bolts per row on each sidewall. Each cable bolt was anchored using two cartridges of resin type MSK2335 and two cartridges of type MSZ2360, while each rock bolt was anchored using one cartridge of MSK2335 and two cartridges of MSZ2360.

In the original support design, the roof was reinforced using 7.3 m-long cable bolts, which were effective in controlling roof deformation and maintaining arch foot stability, meeting the basic requirements for roof support. However, since the entire roadway was laid within the coal seam, the sidewalls composed of fractured coal with low strength and poor self-supporting capacity were prone to continuous deformation under mining-induced stress. The original sidewall support structure was insufficient to restrain this progressive deformation. To address this, the optimized design focuses on reinforcing the sidewalls through the use of grouting cable bolts, which effectively improve the integrity and mechanical strength of the fractured coal mass, transforming the anchorage mode from end-anchoring to full-length anchoring, and forming a framework-type load-bearing structure. Based on the above analysis, a combined support system of “ordinary cable bolts + grouting cable bolts + mesh + W steel belt + shotcrete” was developed, achieving systematic control over both roof and sidewall stability.

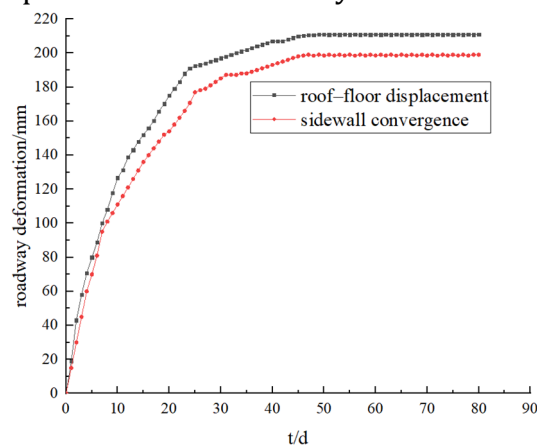
The monitoring results (Figure 8) reveal that roadway deformation exhibited a trend of “rapid initial increase followed by stabilization.” During the first 25 days, deformation developed rapidly, with high convergence rates of both sidewalls and roof–floor displacement. After 25 days, the deformation rate gradually decreased, reaching stability after approximately 45 days. Final data indicate that the maximum sidewall convergence reached 199 mm, and the maximum roof–floor convergence was 211 mm—both within the permissible safety limits. Compared with the original support scheme, sidewall convergence control improved by more than 30%, and roof–floor displacement decreased by 25%.

Figure 8. Convergence Deformation of Roadway Surrounding Rock
